THE UNITED STATES
STRATEGIC BOMBING SURVEY

THE EFFECTS
OF
THE ATOMIC BOMB
ON
HIROSHIMA, JAPAN

Volume III

Physical Damage Division

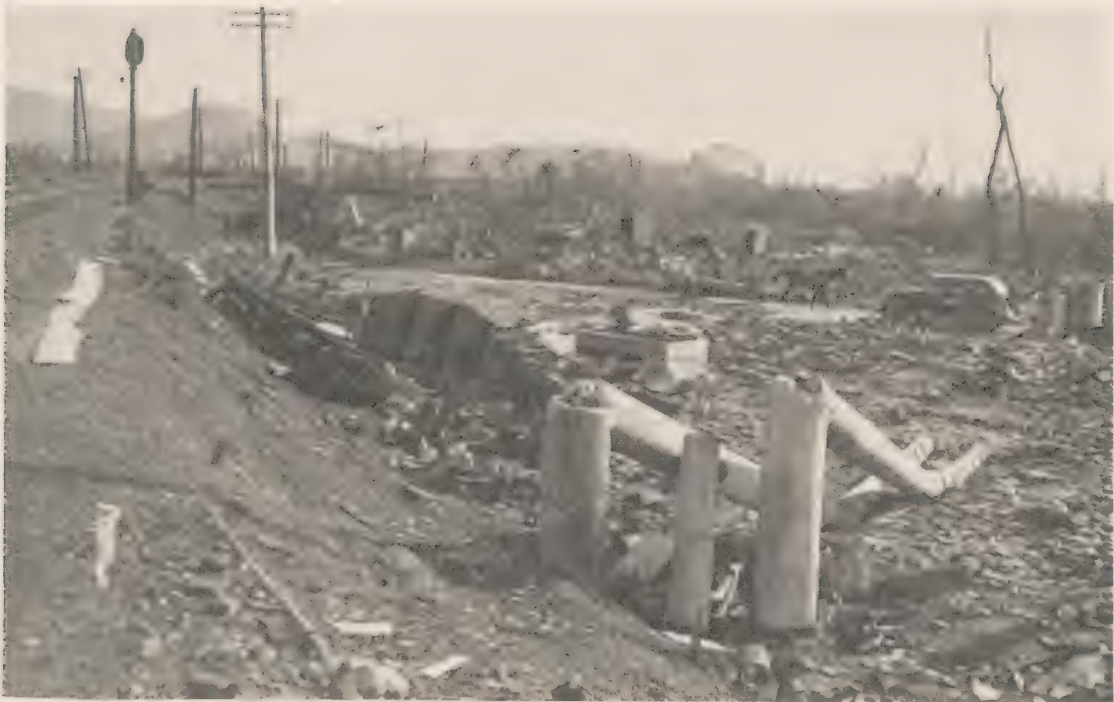
PHOTO 49-XIII. Looking east at damaged freight cars on east end of Bridge 9, 5,800 feet from GZ.

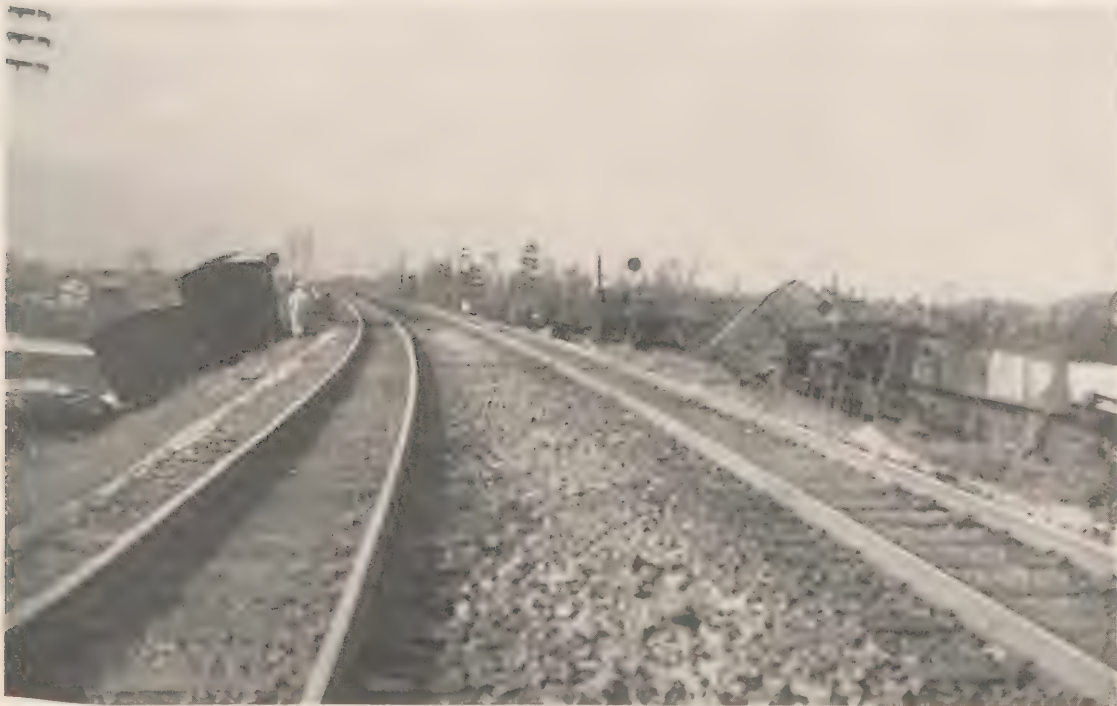
PHOTO 50-XIII. Looking west at damaged freight cars on east end of Bridge 9, 5,800 feet from GZ.

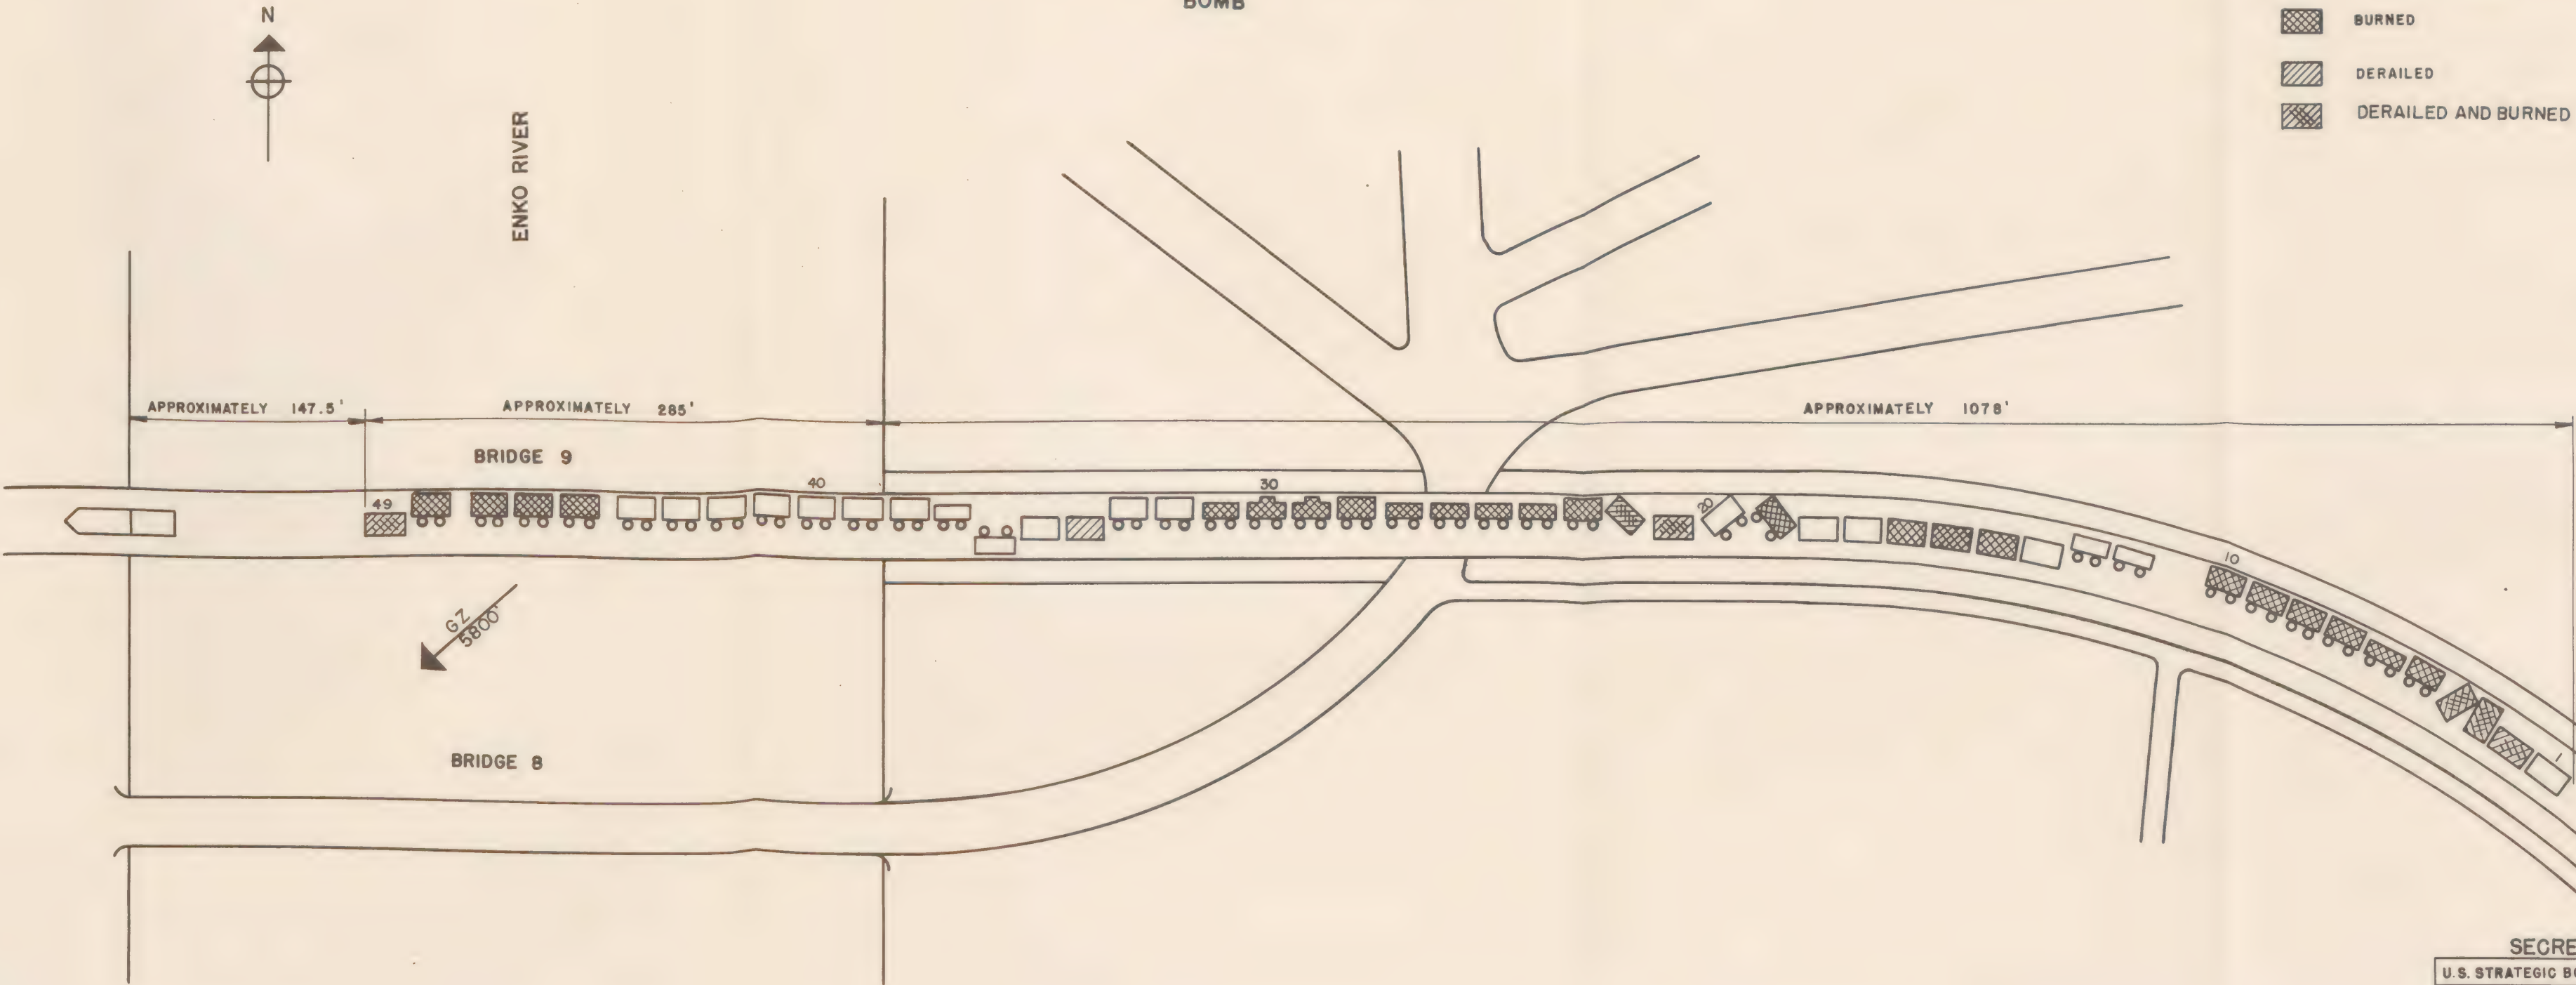
U.S. STRATEGIC BOMBING SURVEY
DERAILING OF FREIGHT TRAIN 377
HIROSHIMA, JAPAN
FIGURE 8 XIII

overturned, or were off the tracks and tilted; also, of 7 cars derailed but upright, 1 was on the bridge and 6 off. The locomotive received only broken glass damage, but the rear trucks of the tender were derailed. None of the train crew was killed, but minor injuries were suffered by a few. The locomotive was disconnected immediately and run to the west abutment of Bridge 9. It was reported by the train crew to railroad officials and to members of the team that fire broke out immediately as a direct effect of the bomb in the first 5 cars behind the locomotive, which were still on the bridge, as well as the 23 cars on the fill section (Photos 49 and 50). The only evidence of fire damage to the bridge consisted of slight irregular charring of a few wooden ties. Table 11 relates to the damaged cars and contents, as told by government railroad officials. It is supplemented by Figure 8.

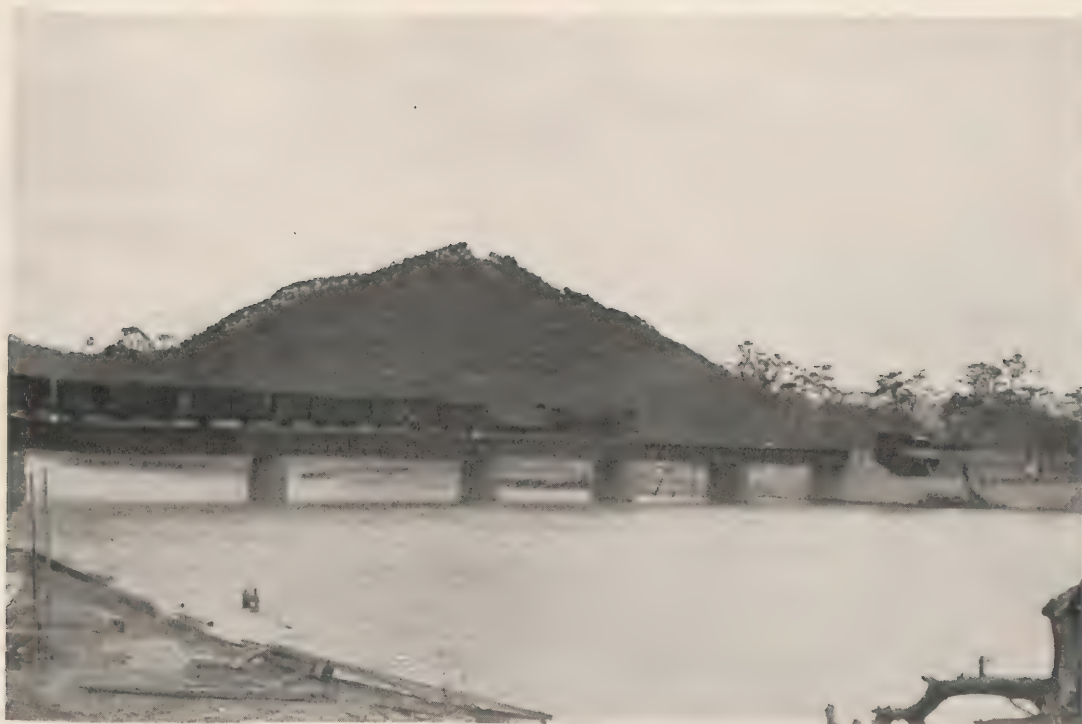
h. There was no damage to the track system or bridges (Photos 51 through 53). The paint on the steel girders of the bridges facing the blast, however, was discolored. All tracks of the Sanyo main line were cleared at 1500 hours on 8 August 1945 and traffic was resumed. Between 6 to 8 August 1945 passengers routed through Hiroshima were compelled to walk between Hiroshima and Koi stations in order to make train connections. Signal systems were inoperative due to damage to the communications office.

PHOTO 51-XIII. Bridge 9. Typical, double-track, railroad bridge, 5,800 feet from GZ.

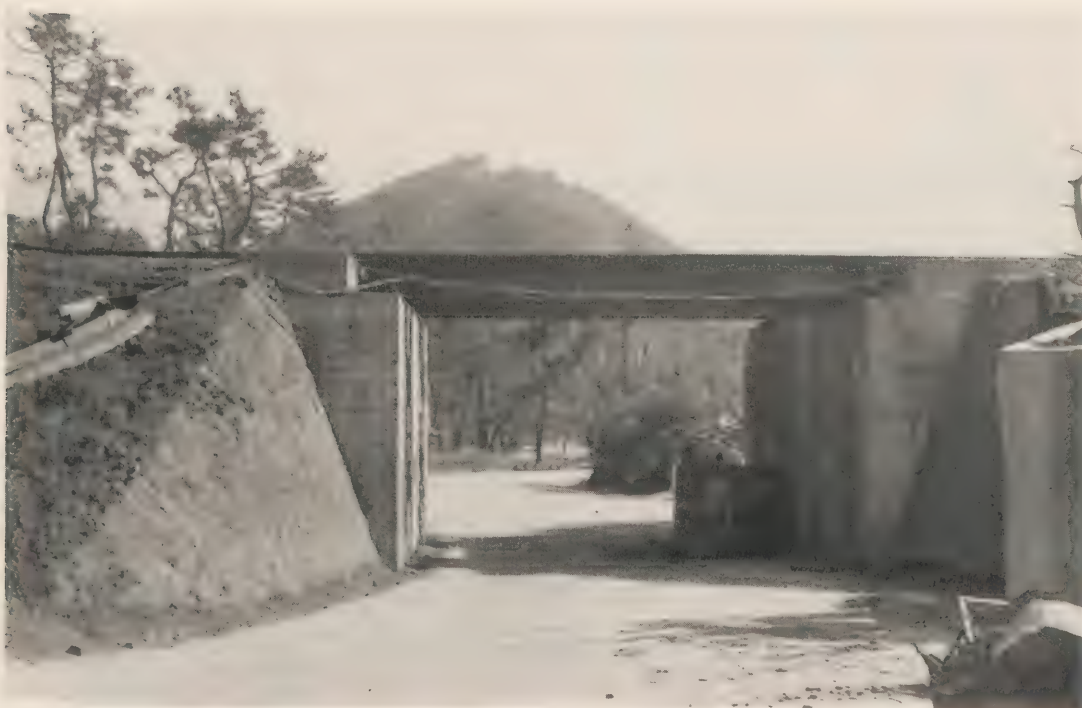
PHOTO 52-XIII. Typical railroad crossing over road, Bridge 8A, 5,600 feet from GZ.

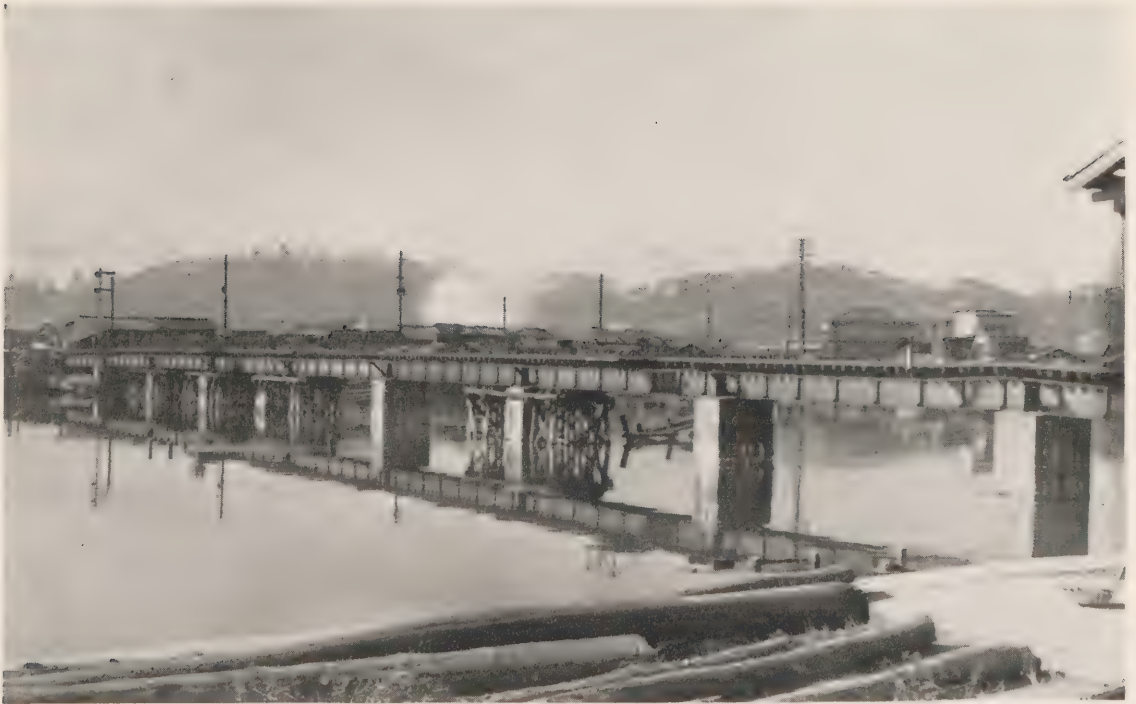
PHOTO 53-XIII. Bridge 2. Typical, single-track, railroad bridge, 8,500 feet from GZ.

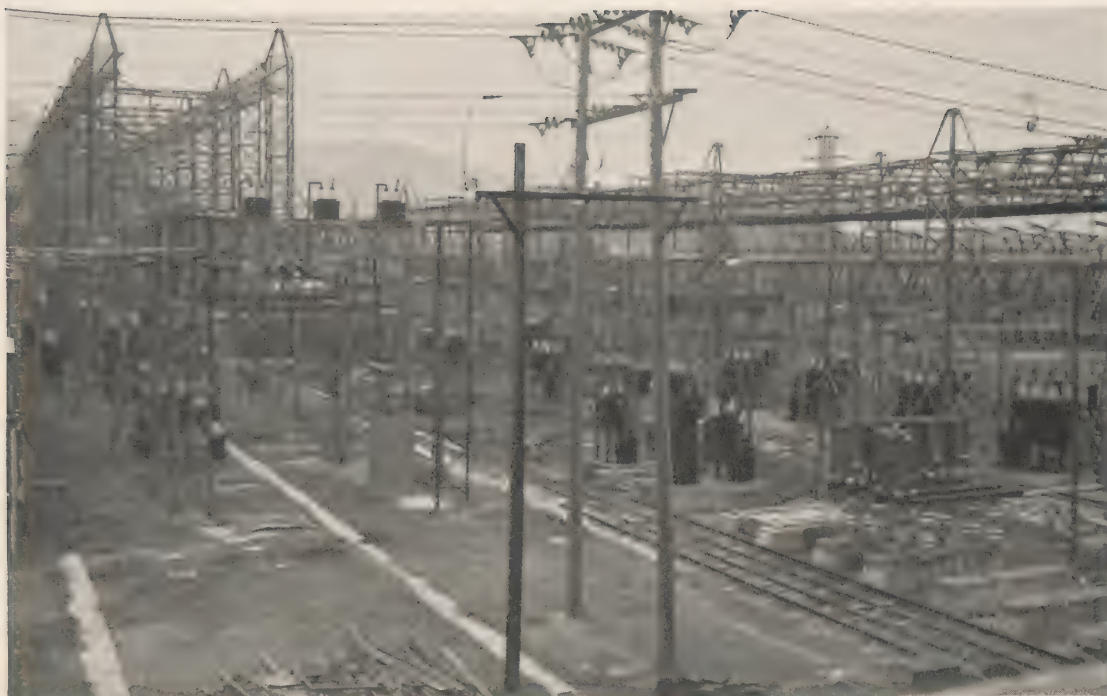
a. The Hiroshima substation (Photos 55, 56, and 57), 15,000 feet from GZ, was undamaged by blast as a direct effect, but the tremendous overload created by the short-circuited damaged electrical equipment in the city of Hiroshima tripped the circuit breakers in this substation and immediately interrupted all electrical service in the Hiroshima area. Officials stated no damage occurred to the equipment and no flash-over was noted. The Hiroshima harbor substation equipment (Photo 58) was undamaged at 14,300 feet from GZ. After investigations by engineers the main substation was in operation the day after the attack, while the Hiroshima harbor substation, although undamaged, was not in operation until 26 August 1945. This delay was due to the difficulty of making inspection in the area in which the 110-kilovolt transmission lines were located.

PHOTO 55-XIII. Undamaged Hiroshima transformer substation of Nippon Electric Co., 15,000 feet from GZ.

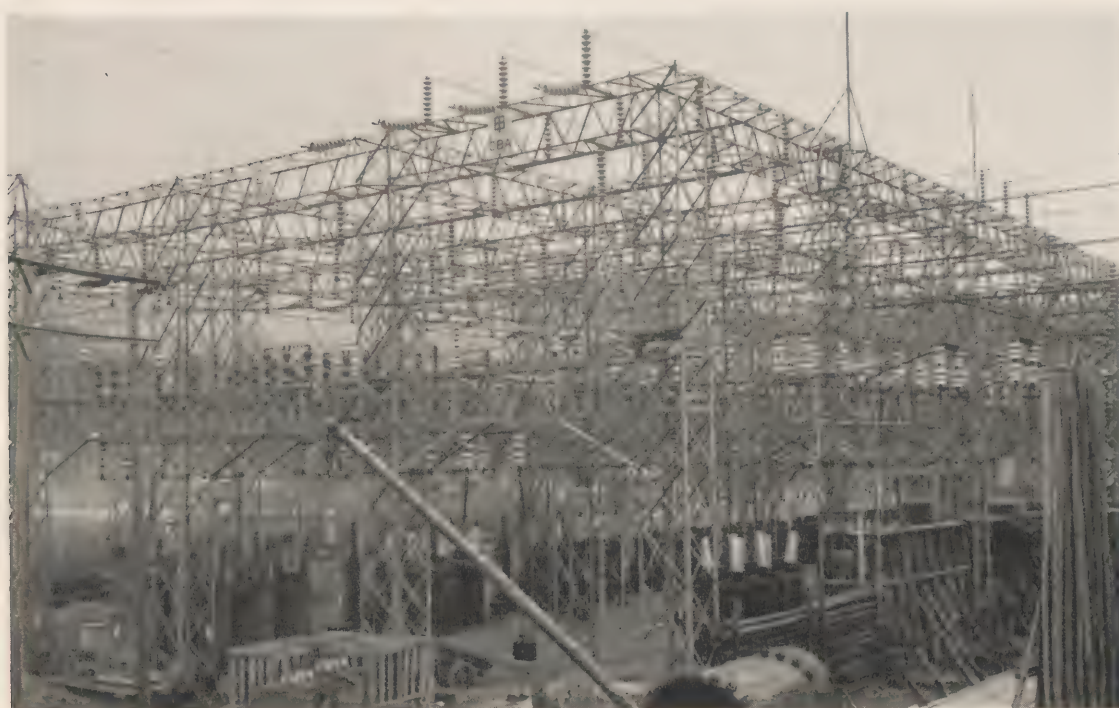
PHOTO 56-XIII. Undamaged Hiroshima transformer substation of Nippon Electric Co., 15,000 feet from GZ.

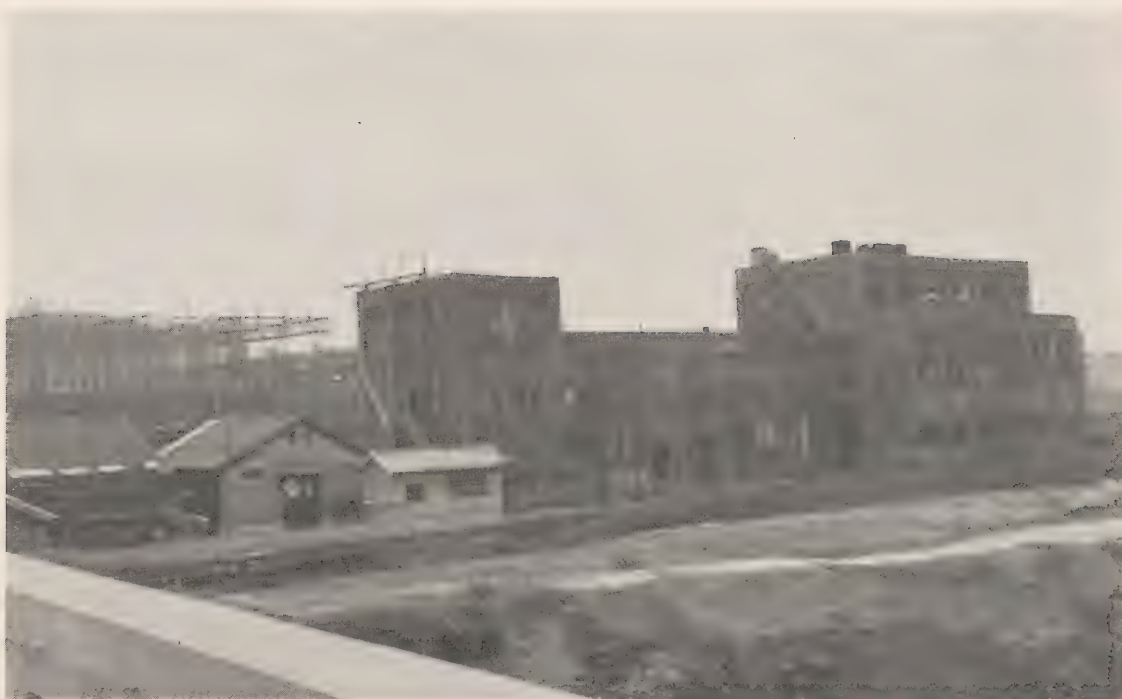
b. The building of the Hiroshima substation (Photo 57) received only minor damage, while the Hiroshima harbor substation building was undamaged. Table 15 gives the damage classification of the Nippon Electric Co. buildings.

PHOTO57- XIII. Minor damage to office building. Hiroshima transformer substation of Nippon Electric Co., 15,000 feet from GZ.

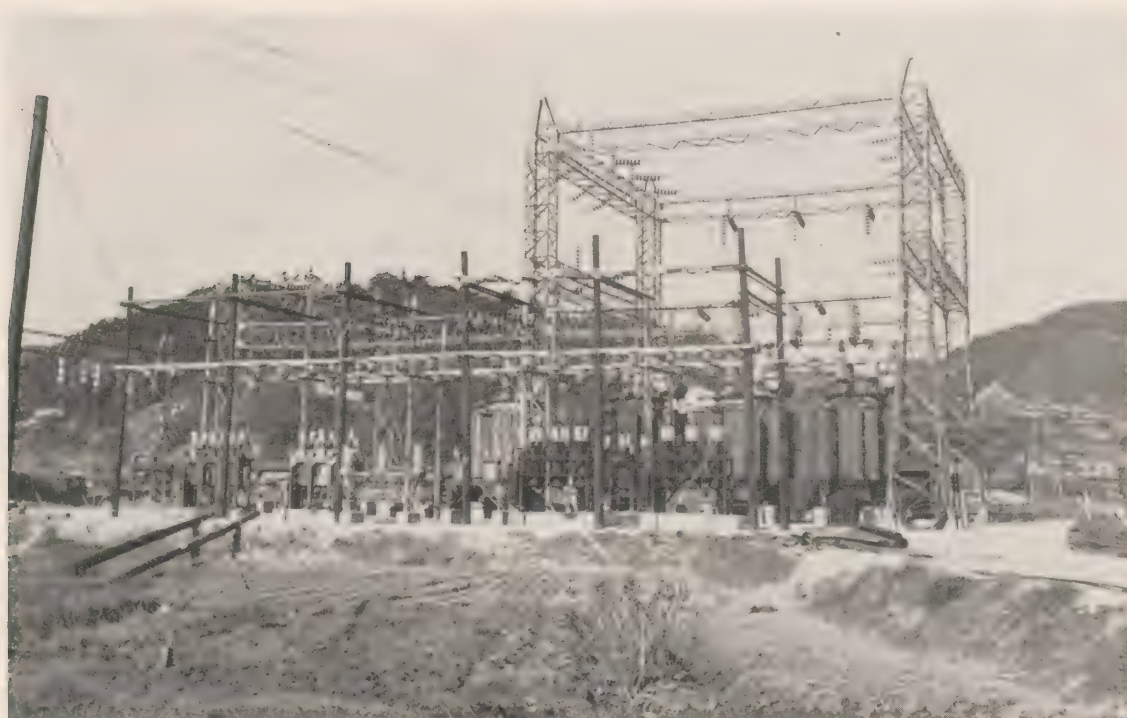
PHOTO 58-XIII. Undamaged Hiroshima Harbor substation of Nippon Electric Co., 14,300 feet from GZ.

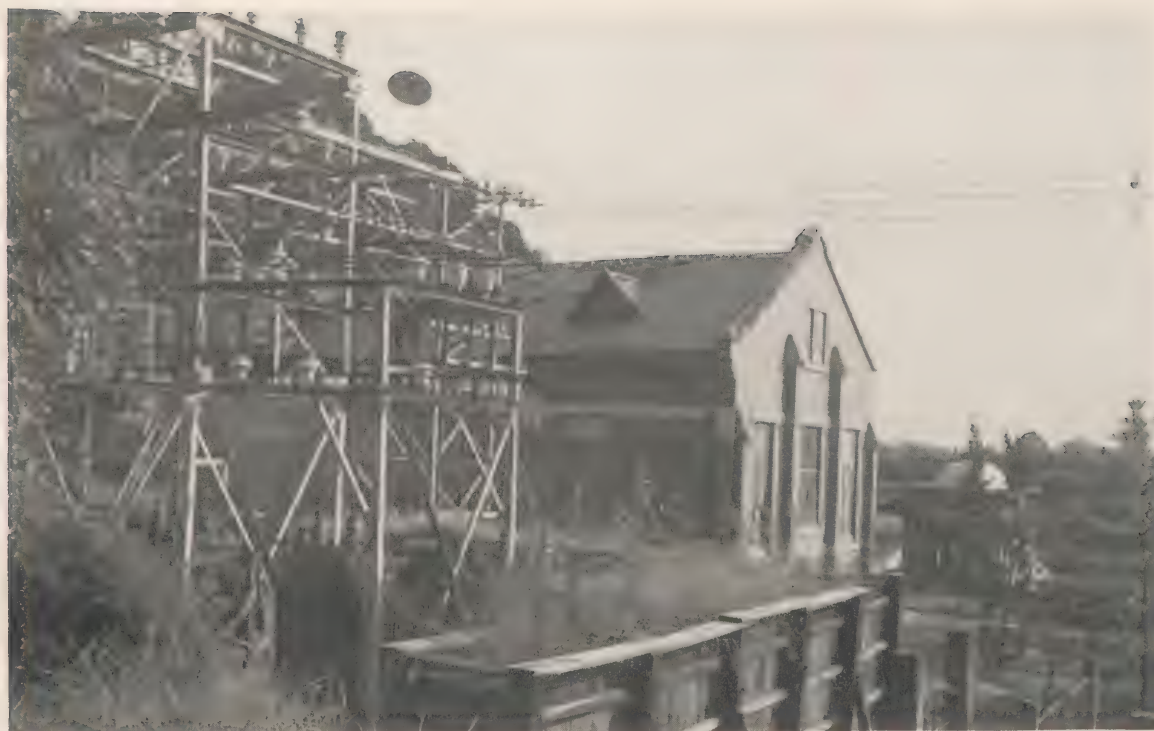
goku Electric Co. at Suigenchi (Photo 59), 9,000 feet from GZ, and at Lambu (Photos 60 and 61), 11,500 feet from GZ, was undamaged by blast or fire. There was no evidence of heavy surges or overloading in these substations, although electrical equipment was damaged in the areas which they supplied. These stations were inoperative due to the power supply cut-off, but were again in service on 9 August 1945. The equipment in the Eba substation (Photos 62 and 63) the Misasa substation (Photos 64 and 65) and the Dambara substation (Photo 66), at 11,800, 5,500, and 7,900 feet, respectively, from GZ, received only slight equipment damage. Two relays in the Eba substation and 4 relays in the Dambara substation were damaged by falling debris and overloading of the circuits. The switchboard, including instruments, wiring, and other panel equipment in the Misasa substation, was damaged by blast and debris. The two relays in the Eba substation were replaced on 11 August 1945, but the station was not in operation until 20 August 1945 because no power was being transmitted from the Hiroshima Harbor substation until that time. The four relays in the Dambara substation were not replaced until September 1945, but the circuits were rewired to shunt out the relays, and the substation was in operation on 9 August 1945. Because of the difficulty of access to the Misasa substation, temporary repairs to enable the substation to operate were not completed until 8 September 1945. The substations at Otemachi (Photos 67 and 68) and Sendamachi (Photos 69, 70, and 71) were sufficiently damaged at 2,400 and 7,700 feet, respectively, from GZ to put them out of service for an indefinite period. The equipment at the Otemachi substation (Photo 68) was dislodged by the effects of the blast and was further damaged by fire caused by short circuits in the equipment. The substation at Sendamachi was heavily damaged by fires originating in the areas adjacent to the substation. Generator coils were burned out and the switchboard totally damaged (Photo 69). Turbine and generator bearings were also damaged. Some distortion to shafting and turbine blades was indicated. Boiler-room damage (Photo 71) was confined to distortion of pipes and metal, but small motors and pumps for collateral equipment were heavily damaged. The transformers (Photo 70) were not damaged, but busbars and insulators received slight damage and all leads to the transforming equipment were totally damaged by blast

PHOTO 59-XIII. Undamaged Suigenchi substation. Note transformer protection, 9,000 feet from GZ.

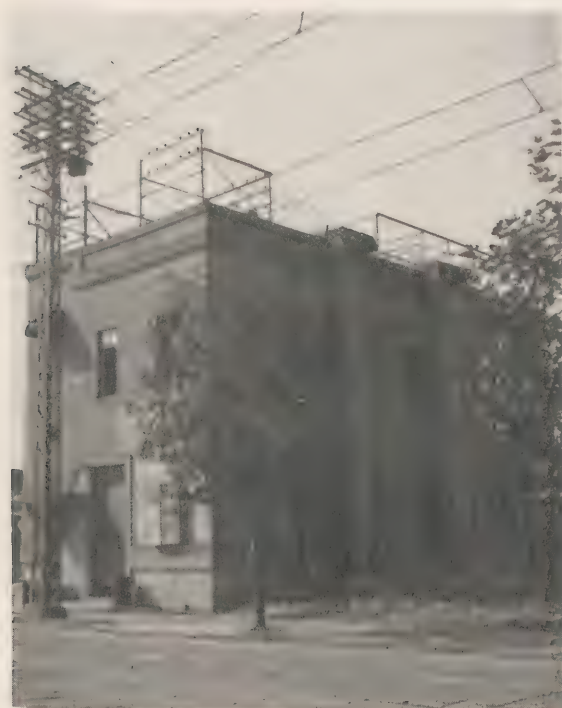
PHOTO 60-XIII. Undamaged exterior of Nambu substation, 11,500 feet from GZ.

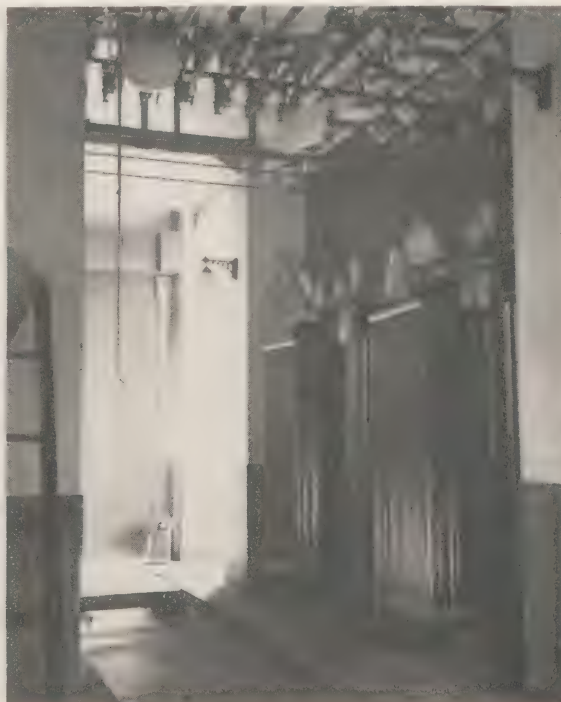
PHOTO 61-XIII. Undamaged interior of Nambu substation.

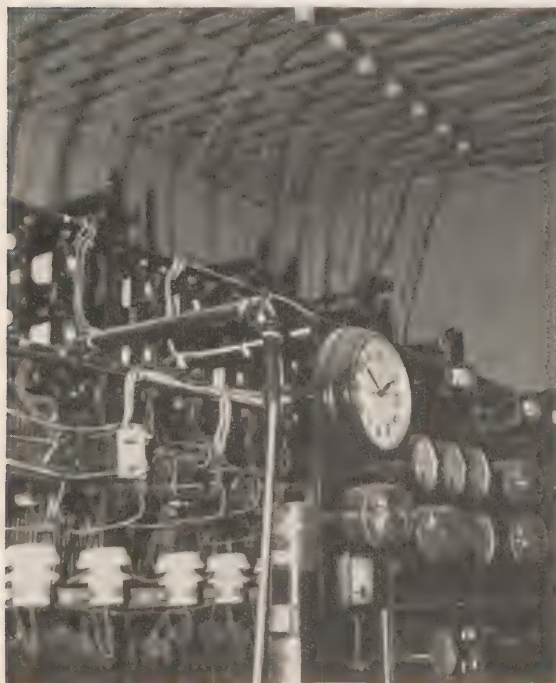
PHOTO 63-XIII. Panel of Eba substation.

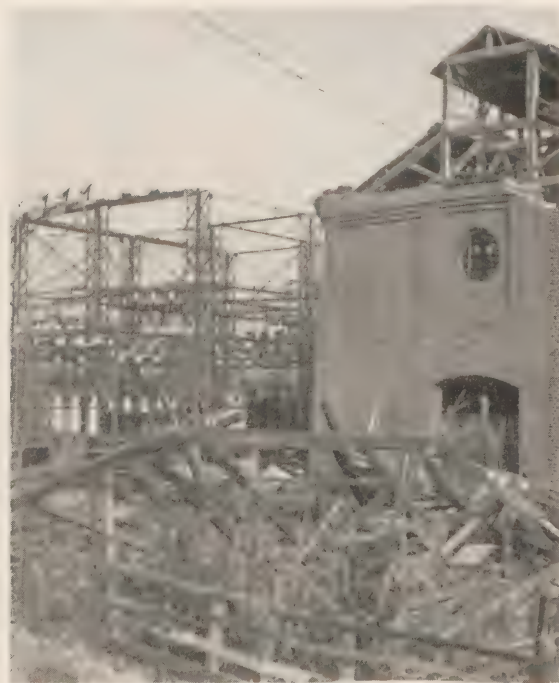
PHOTO 64-XIII. Blast damage to Misasa substation, 5,500 feet from GZ.

d. Of the 7 substations and one office building of the Chugoku Electric Co., the office building (Photo 72) alone received structural damage by blast. The Eba (Photo 62), the Otemachi (Photo 67), Misasa (Photo 64), and Nambu (Photo 60) substations were damaged to a minor degree only. The Suigenchi substation (Photo 59) had no attached building but depended on Building 6 of the purification plant (Part E of this section) for housing its recording equipment. Damage classification of all substation buildings is given in Table 15.

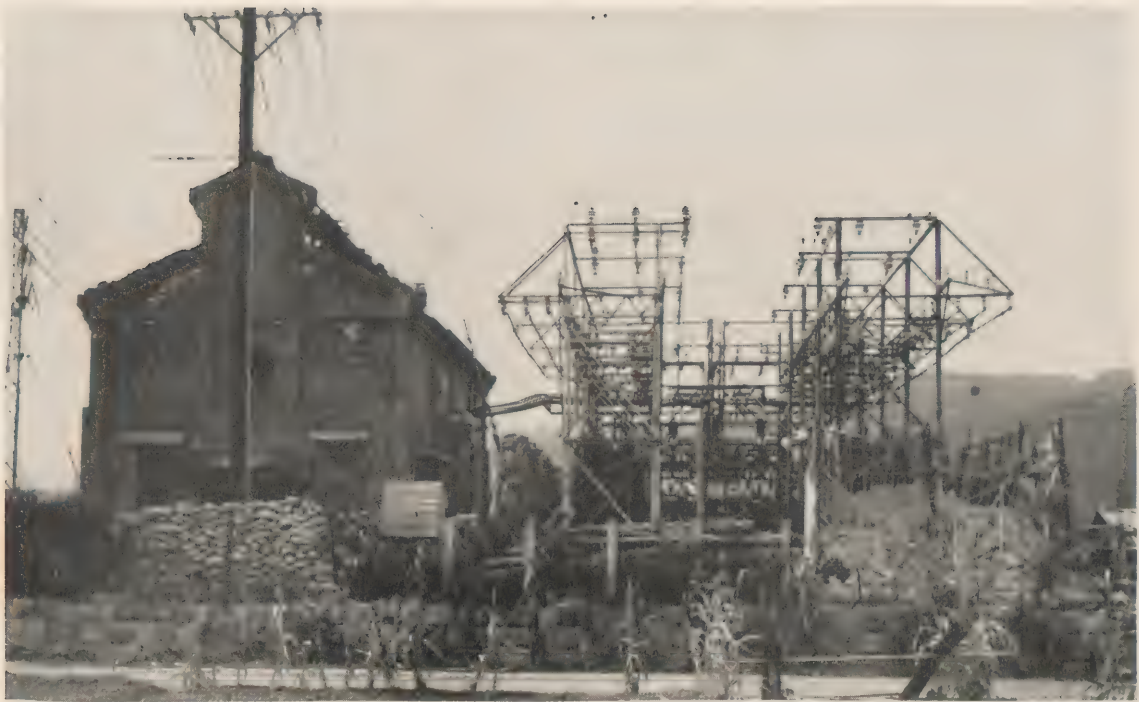
PHOTO 65-XIII. Undamaged busbars and transformers at Misasa substation, 5,500 feet from GZ.

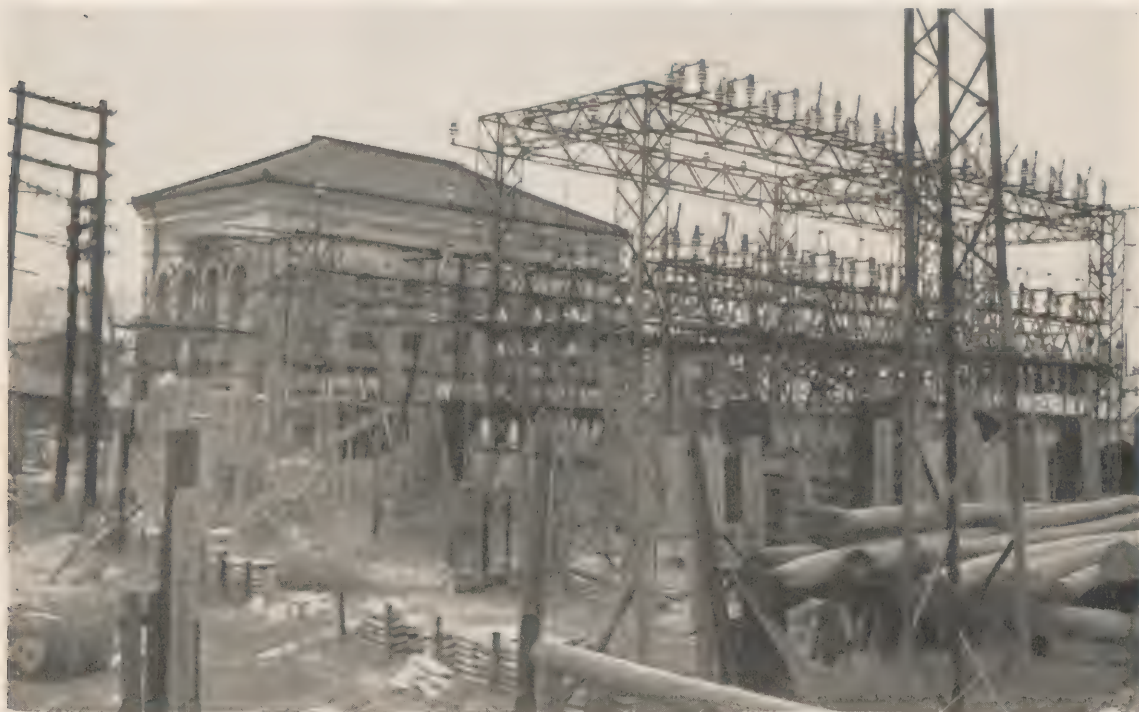
PHOTO 66-XIII. Dambara substation showing undamaged busbars and transformers, 7,900 feet from GZ.

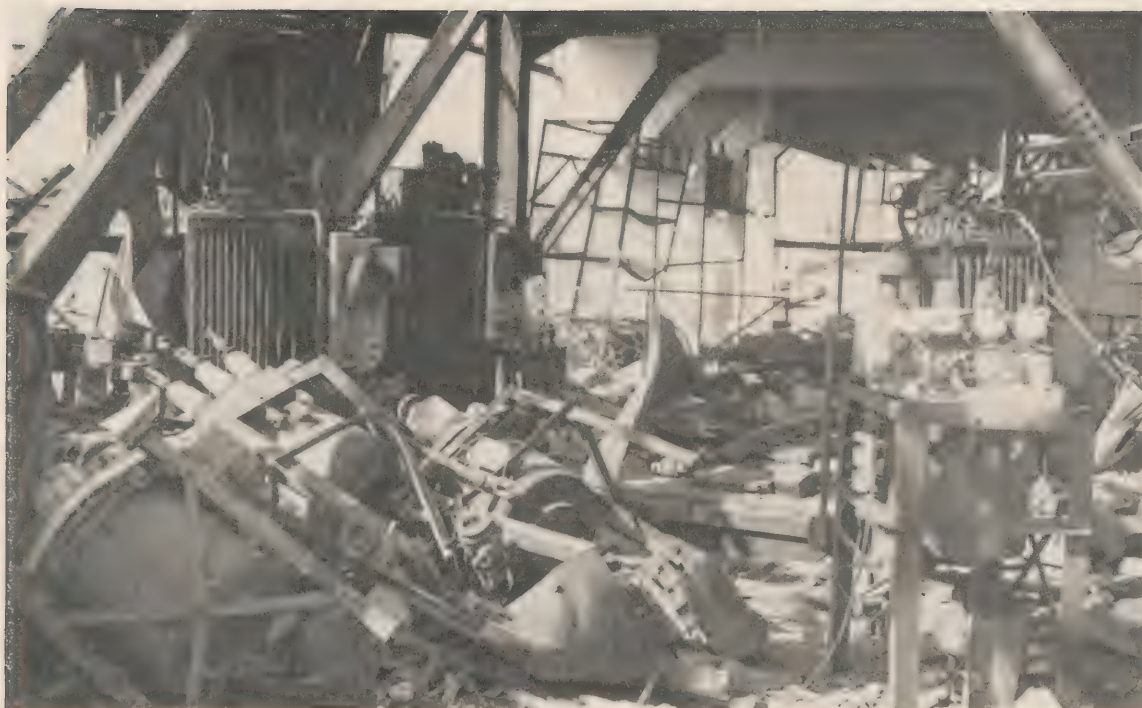
PHOTO 68-XIII. Equipment damage to Otemachi substation, 2,400 feet from GZ.

Substation	Grid	Distance from GZ (feet)	Damage type	Cause
Dambara.....	5J	7,900	Slight.....	Debris and overload.
Suigenchi.....	1I	9,000	None.....	
Otemachi.....	5H	2,400	Heavy.....	Blast and fire.
Misasa.....	3F	5,500	Slight.....	Blast.
Sendamachi				
Turbo-Generators.....	7H	7,700	Heavy.....	Fire.
Boilers.....	7H	7,700	Slight.....	Do.
Transformers.....	7H	7,700	do.....	Blast and fire.
Nambu.....	9H	11,500	None.....	
Eba.....	8E	11,800	Slight.....	Debris and overload.

The engineers of the Chugoku Electric Co. were unable to give the approximate date when the Otemachi or Sendamachi substation would be repaired and resume operations. Although the damage to the transformers and collateral equipment at the Sendamachi substation was slight, little or no effort was expended in placing the system in operation.

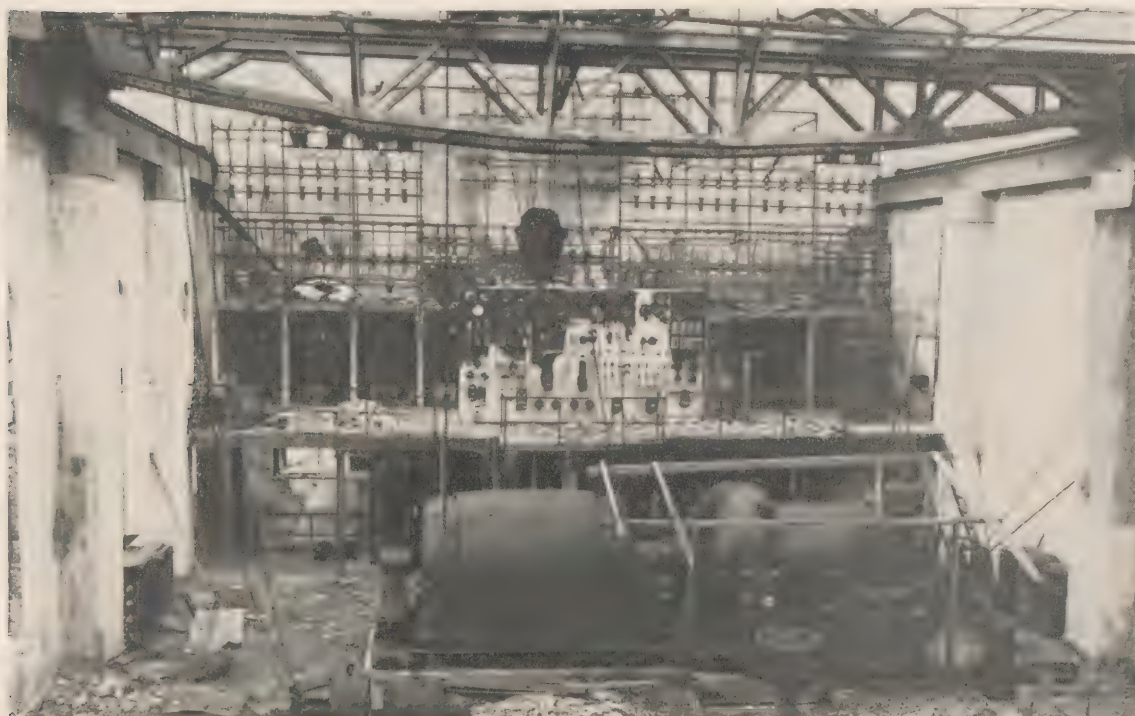
PHOTO 69-XIII. Turbine and switchboard damage at the Sendamachi substation, 7,700 feet from GZ.

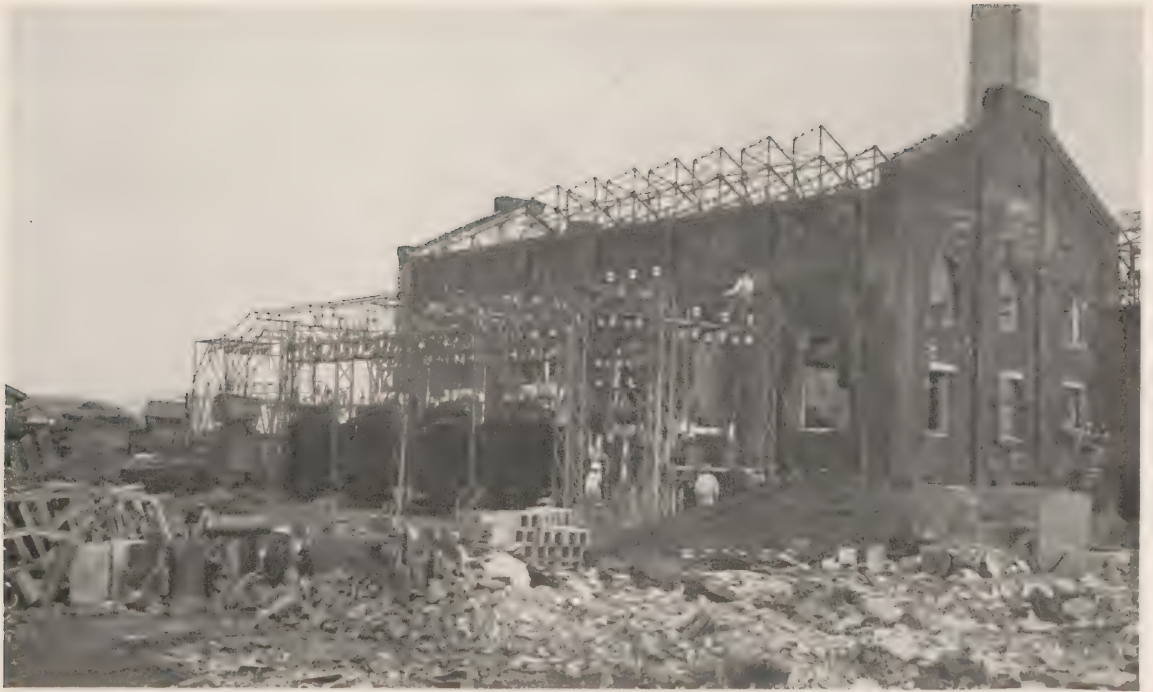
PHOTO 70-XIII. Damage to exterior equipment at Sendamachi substation. Busbars being repaired.
Note that out-going lines are down.

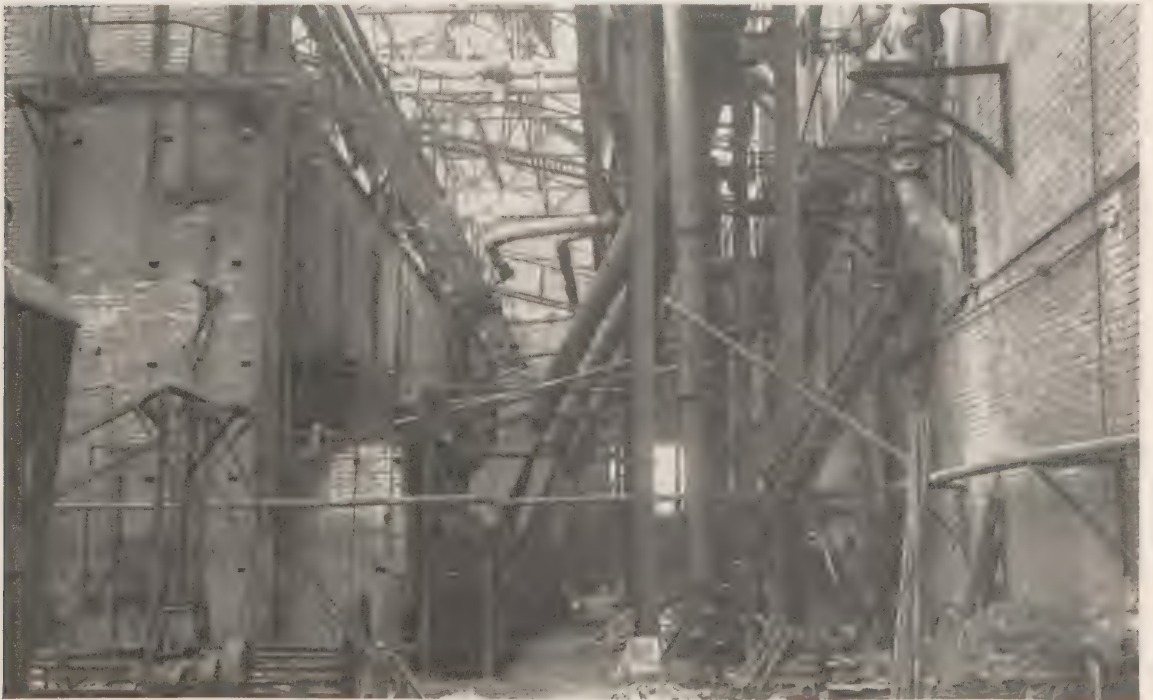
PHOTO 71-XIII. Sendamachi substation boiler room damage. Boiler steel warped by heat and collateral equipment damaged by fire.

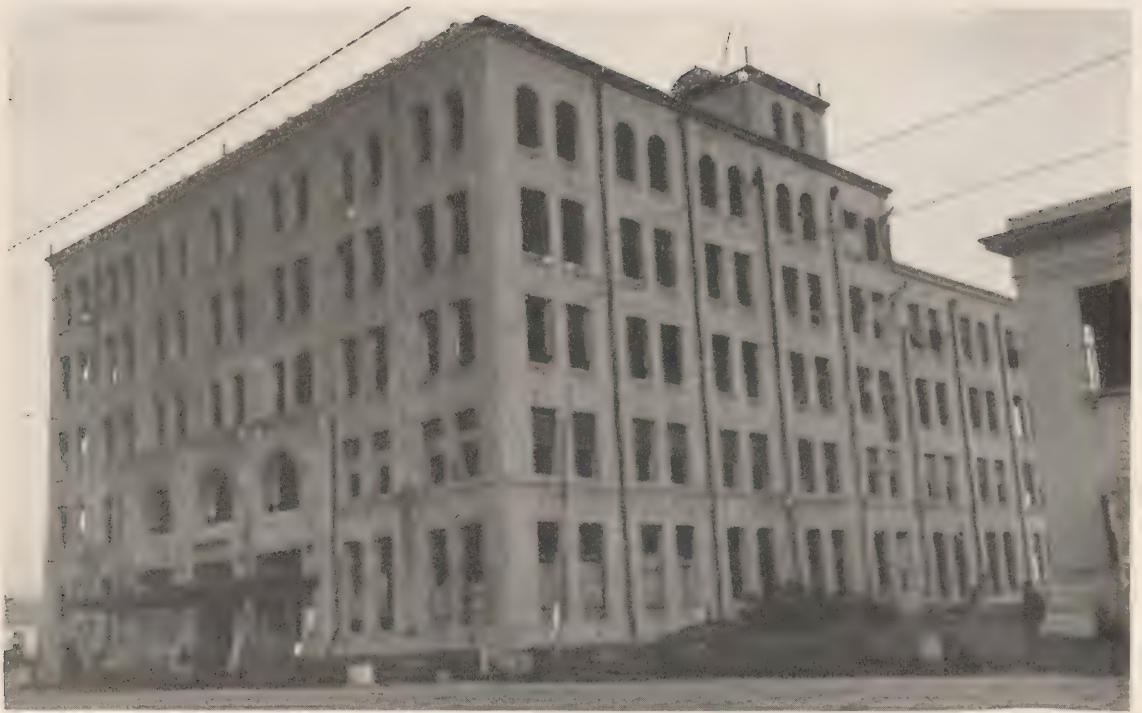
PHOTO 72-XIII. Blast damage to the office of the Chugoku Electric Co. (Bldg. 26), 2,300 feet from GZ.

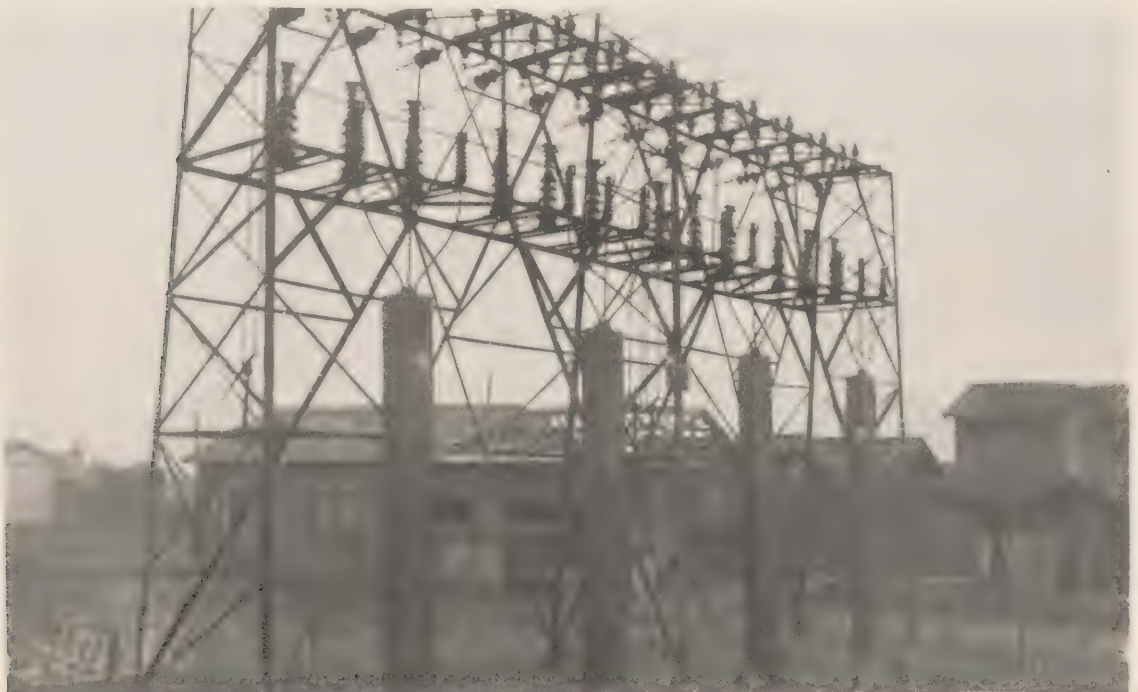
f. The 110-kilovolt, high-tension lines of the Nippon Electric Co. were undamaged, the nearest point of these lines being 11,000 feet from GZ. There was neither blast nor fire damage to the 22-kilovolt overhead transmission lines (Photo 73) of the Chugoku Electric Co., although the 22-kilovolt overhead lines which supplied the Misasa substation (Photo 74) were only 5,700 feet from GZ. Approximately 70 percent of the 3.3-kilovolt overhead transmission lines and feeders, including pole-mounted transformers, was damaged by blast

PHOTO 73-XIII. Conversion from overhead transmission system to subsurface system. Undamaged at 9,500 feet from GZ.

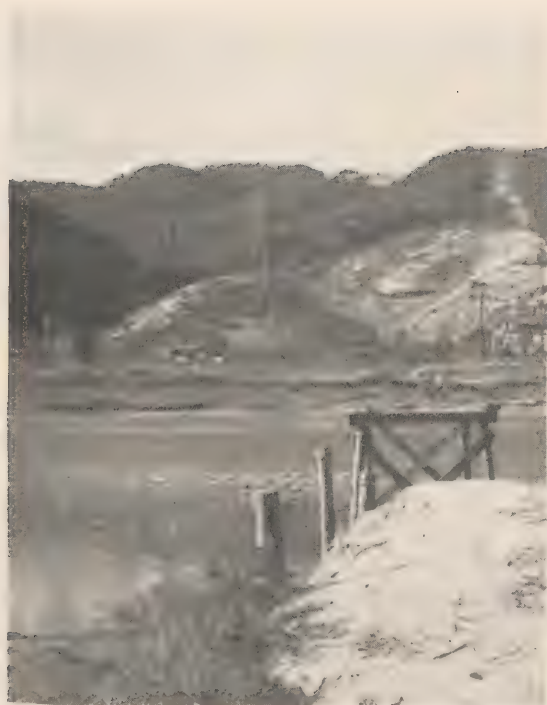
PHOTO 74-XIII. High tension tower, 6,500 feet from GZ, undamaged.

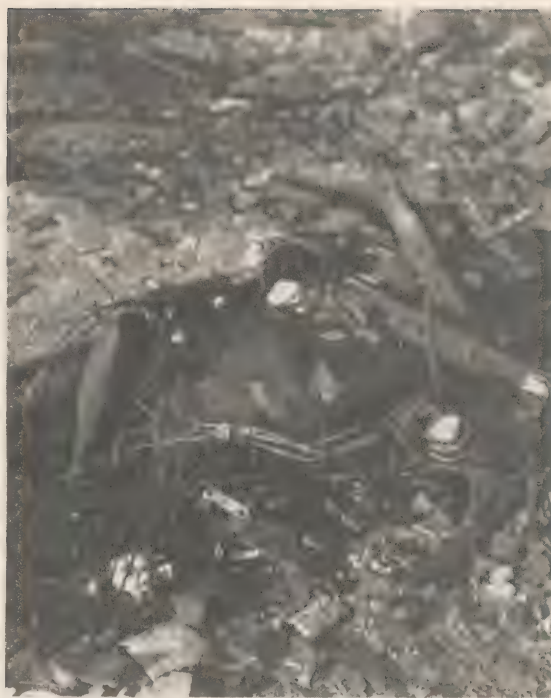
g. Of the 70 percent of the 3.3-kilovolt overhead lines and feeders damaged, it was estimated that 10 percent could be salvaged for reuse with the exception of the pole-mounted transformers (Photo 75), which were totally damaged, requiring 100 percent replacement. The remaining 30 percent of the overhead was only 90 percent operative because the overhead transmission beyond the points of damage could not be supplied with electricity due to the heavy damage in the Otemachi and Sendamachi substations. The 3.3-kilovolt lines in these areas which were undamaged were divided among the adjacent substations, and supplied with power by shunting around the Otemachi and Sendamachi substations and interconnecting with the other available substations. Figure 10 shows the extent of damage and replacement of overhead.

PHOTO 75-XIII. Pole-mounted transformer damaged by fire, 200 feet from GZ.

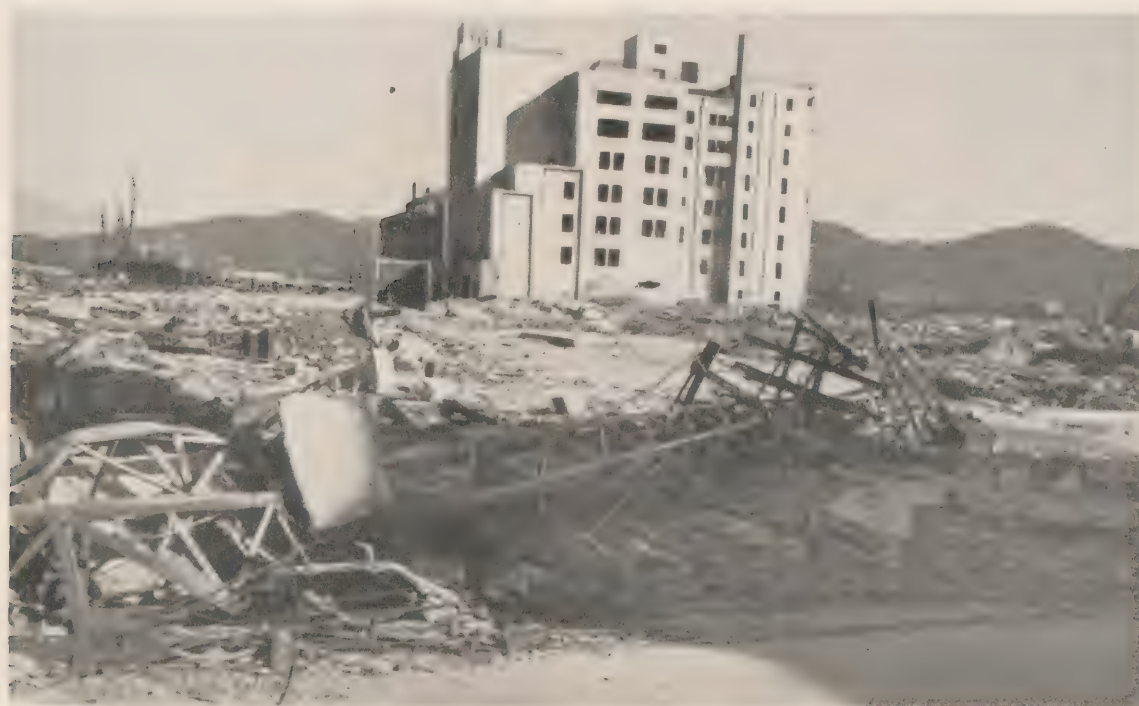
and fire. (NOTE.—In the following pages, photos with an asterisk (*) will be found in Part A, and those marked with a number sign (#) will be found in Part C of Sec. XIII.) Of the 6,400 wood poles (Type 1), 500 were broken by blast (Photos *16, 76, 77, 78, 79, 80, 81, 82, and 84), and 3,500 were burned (Photos 82, 85, 87, and 88). Of the 30 steel-lattice poles (Type 3) 6,000 feet from GZ, 27 were damaged by blast (Photos *17, *19, *22, 76, and 77), having been bent at the base. No concrete poles (Photo *23) were damaged, the nearest concrete pole being 6,000 feet from GZ. Overhead transmission wires were found parted and down 8,000 feet from GZ as a result of blast (Photos *86 and *88). The limits of damage to the types of poles of the Chugoku Electric Co. are shown on Table 19.

PHOTO 76-XIII. Steel lattice and wood pole 2,000 feet from GZ.
